Inspection of an Underground Shollar Drinking Water Reservoir and Strengthening of a Design Taking into Account Square Ecology

Abstract: Historic facts of design and construction of the region's first industrial tank for drinking water are given in article. For strengthening of a design use of carbon fiber tape and laminating superficial fittings on an epoxy basis was offered. Models of the walls strengthened by carbon fiber fittings were tested for tension and a bend. As a result of test linear deformations under loading are also defined necessary mechanical characteristics of composite material - the elasticity module, Poisson's coefficient, the tension resistance, a support angle of rotation during a bend. The tests are conducted in the experimental polygon of the Construction materials research institute.

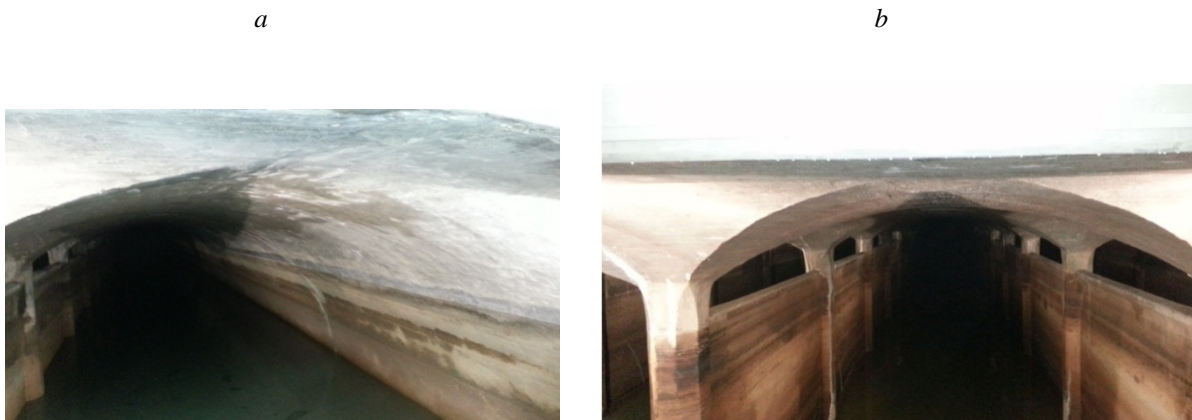
Figure 3. Internal view of first - a (1911-1917) and second -b (1928-1932) reservoir structure.

Multiple cracks on walls of a construction promoted introduction of water in thicknesses of concrete and to change quality of material of a construction (Figure 3). And it in turn does harm to stability of all design. Cracks in the basis at the bottom of a reservoir promote leak of drinking water under the base of a construction. It leads to an emergency of a construction and destruction of the general hydrological and hydro geological structure of the environment. Such leak of water within 100 years has led to weakening of the soil basis under a construction. The reservoir constructed by a row later in 1928 has other constructive scheme. Small caps reinforced concrete columns under the influence of vertical loading and constant humidity on the verge of total loss of stability and durability.

From this point of view, that is for increase to resistance to tension and providing an internal waterproofing of a construction it has been decided to reinforce a construction completely external carbon fiber tape and laminating strips from within and then to cover shut-cup concrete.

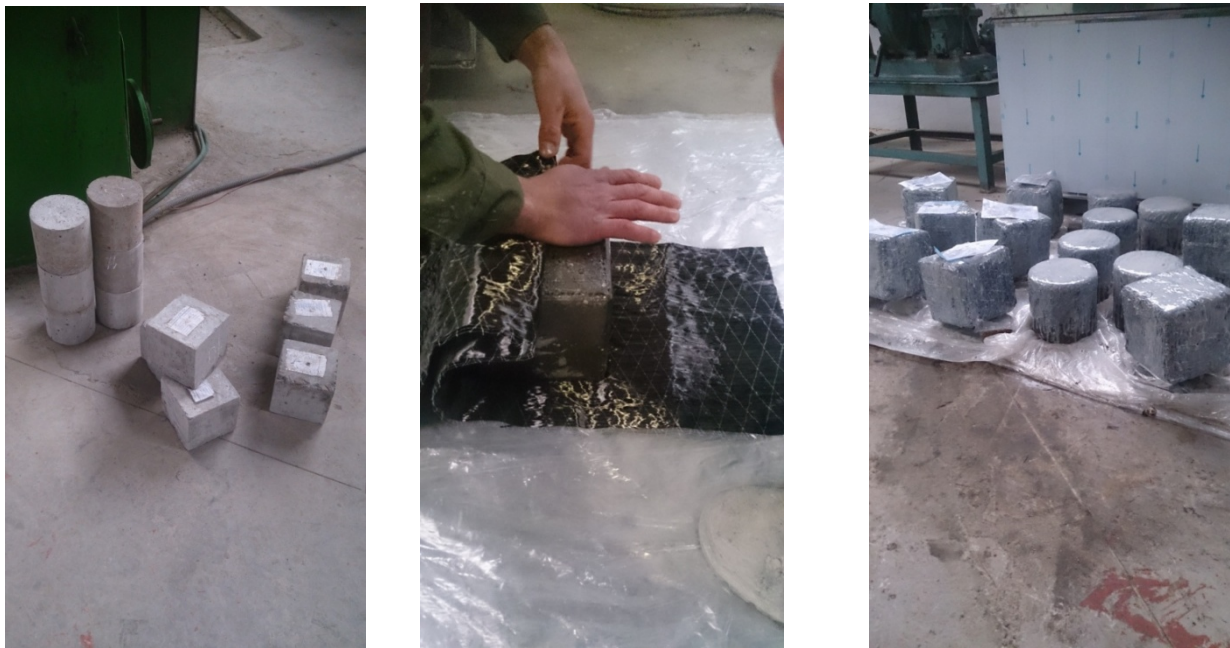
Figure 8. Isolation and preparation of concrete samples with a carbon fiber holder to test.

On the ground of institute tests of the samples protected by a carbon fiber tape on the water resistance (humidity), water tightness and frost resistance have been carried out. As carbon fiber material the material Magnal Laboratory for Concrete Research Institute (Belgium) was used. Epoxy of the CCS EP Grout brand. Tests were carried out on concrete cubes by the size $150 \times 150 \times 150$ of mm and cylinders the mm size 150×150 . The used concrete for samples corresponded to durability to the class B15, frost resistance of the class F300 and water tightness of the class W6.
